TRAUMA

CERVICAL SPINE INJURIES

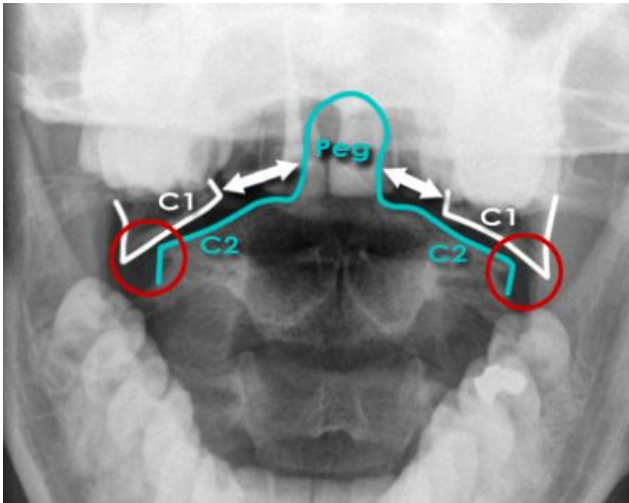
Left: Jefferson Fracture

Unstable burst # of C1 caused by axial load injury. The ring structure is disrupted and the spaces between the peg and the C1 lateral masses are widened. The lateral masses of C1 no longer align with those of C2.

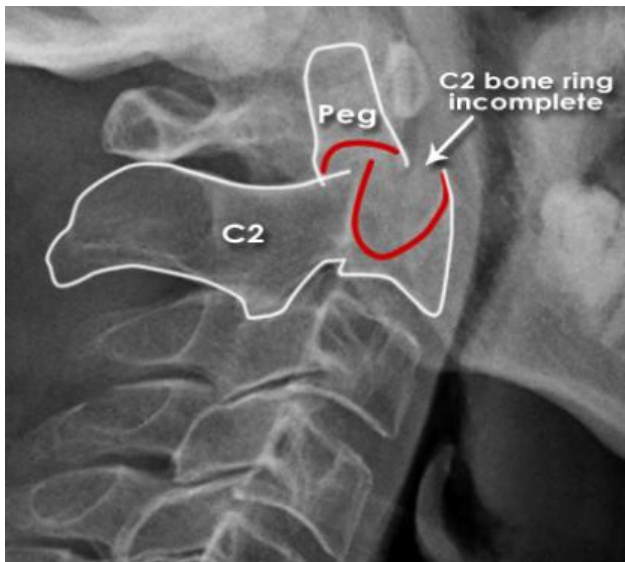
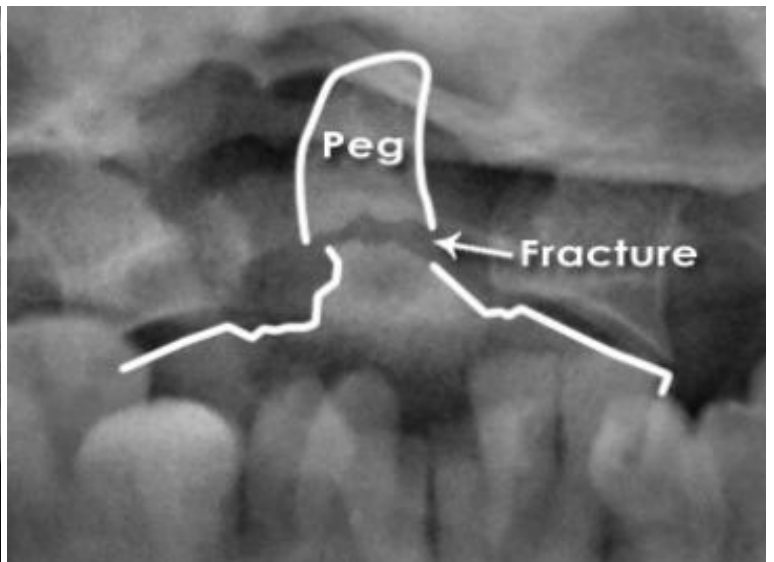
Below: Odontoid Peg Fracture

Occurs due to hyperflexion (anterior displacement) or hyperextension (posterior displacement) injury.

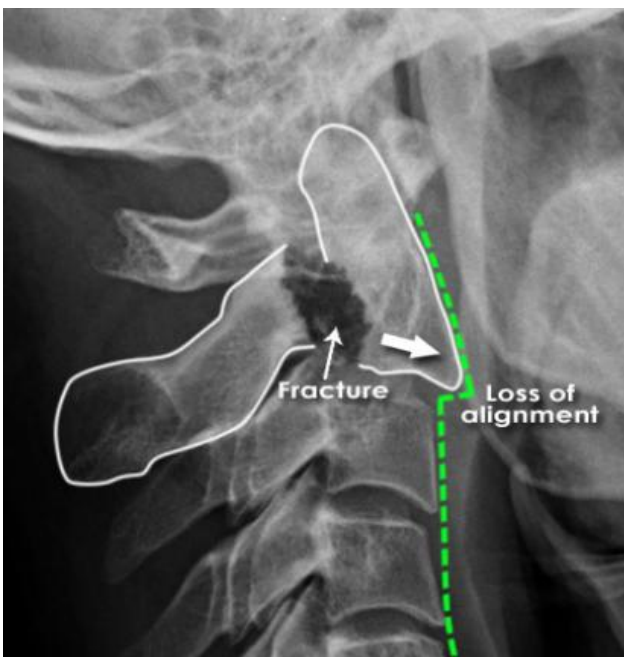
Left: Hangman Fracture

This is a fracture through both pedicles of C2 which results from a high force hyperextension injury, usually from a high speed RTA.

There is often anterior displacement of the body and odontoid peg of C2 which causes loss of alignment in the anterior vertebral line.

If the fracture extends to the transverse foramina a vertebral artery injury should be considered.

This is an unstable fracture.

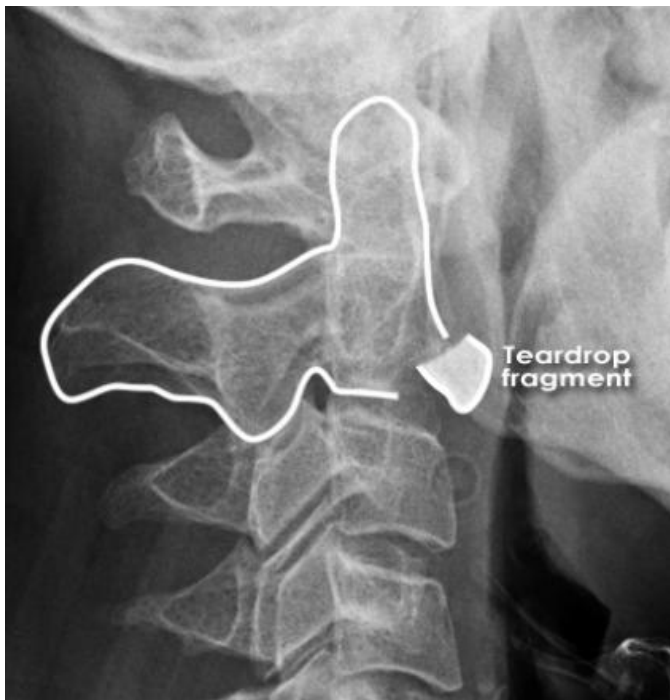
Above left: extension teardrop fracture. Hyperextension results in avulsion of the anterior corner of the vertebral body, (usually C2) which remains attached to the anterior longitudinal ligament. Disruption of this ligament leads to instability.

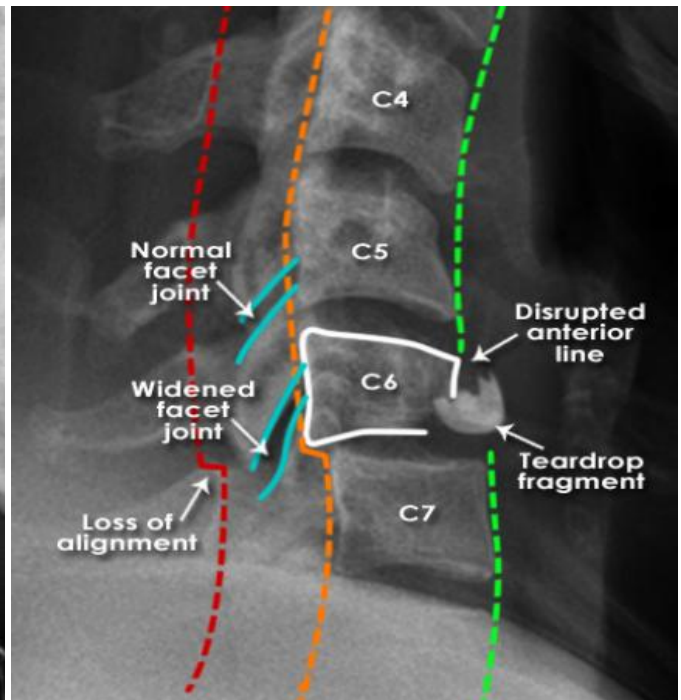
Above right: flexion teardrop fracture. An unstable injury between C3-C7 due to flexion & compression (RTA deceleration, diving). There is fracture of the anterior corner of the vertebral body, posterior displacement above the level of the injury, spinous process widening and facet joint dislocation.

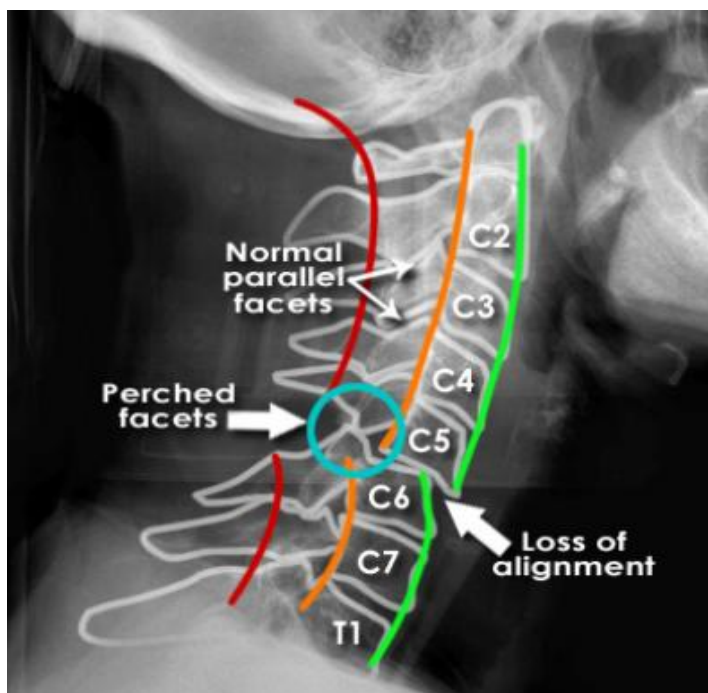
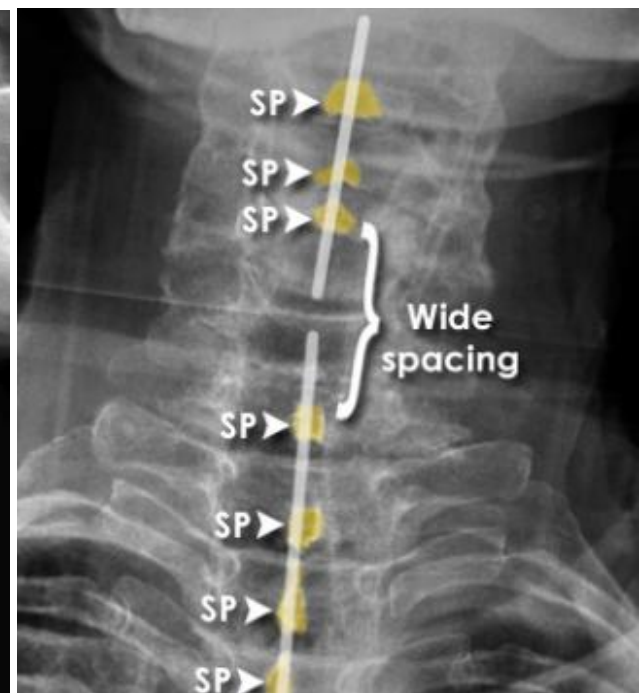
Below: bilateral perched facets. There is facet joint dislocation where the inferior articular processes appear to sit ("perch") on the superior articular processes of the vertebra below. It is caused by hyperflexion and is unstable. There is often anterolisthesis and spinous process widening.
